MISCELLANEOUS PAPER S-73-42

# CONDITION SURVEY, GRAND FORKS AIR FORCE BASE, NORTH DAKOTA

P. J. Vedros, H. T. Thornton, Jr.

June 1973

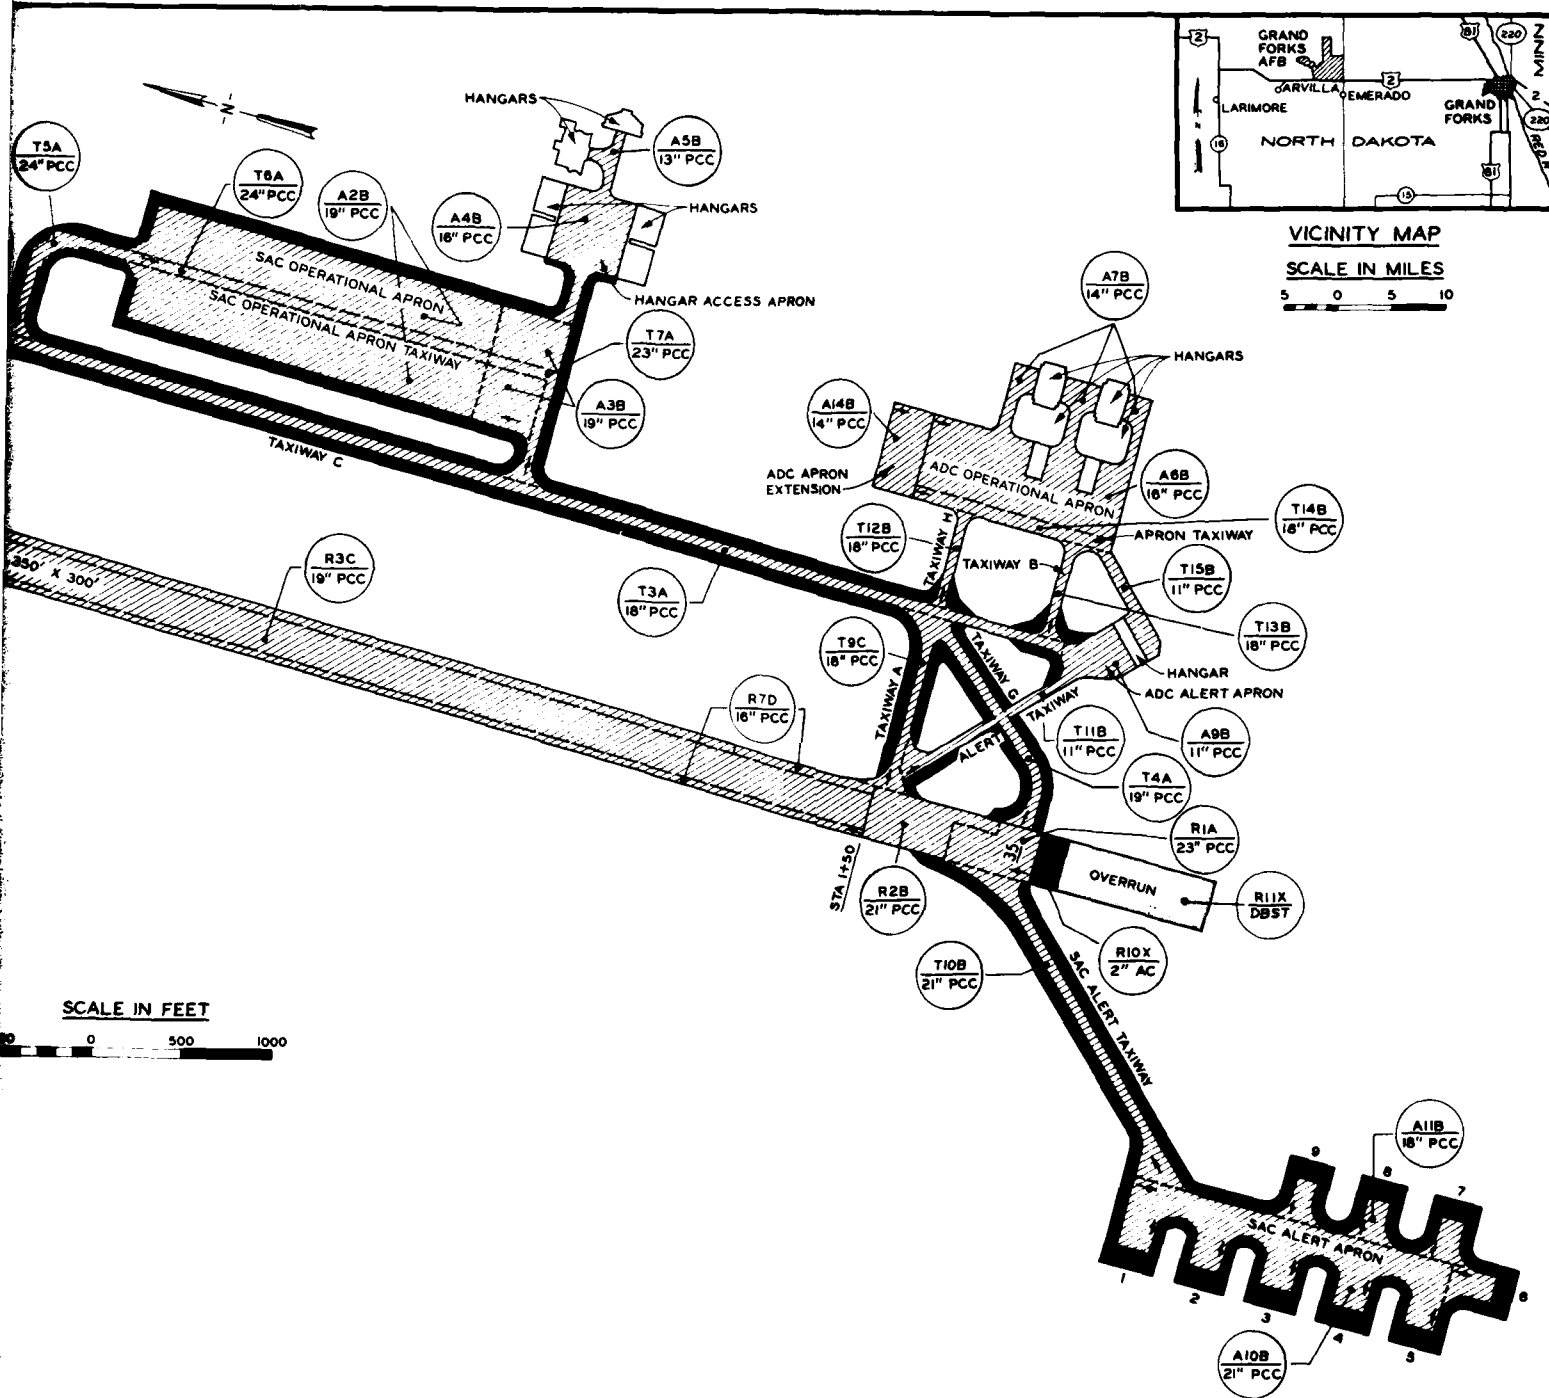
GRAND FORKS AFB  
AIRFIELD LAYOUT AND PAVEMENT PLAN

shown in plate 1. The general topography of the site is of a comparatively flat to gently rolling nature. The airfield elevation is 911 ft above mean sea level. The airfield site is located on the edge of ancient Lake Agassiz, which was formed as a retreating glacier blocked the flow of melting ice to the north. The foundation materials are heterogeneous, consisting of clays of CL-CH classification,\* with some areas of silts and sands. The normal subgrade modulus K varies from about 100 to 175 pci.
